Career Episode 2

Resilience in Telecommunications: Troubleshooting, Maintenance, and Disaster Recovery at Globe Telecom

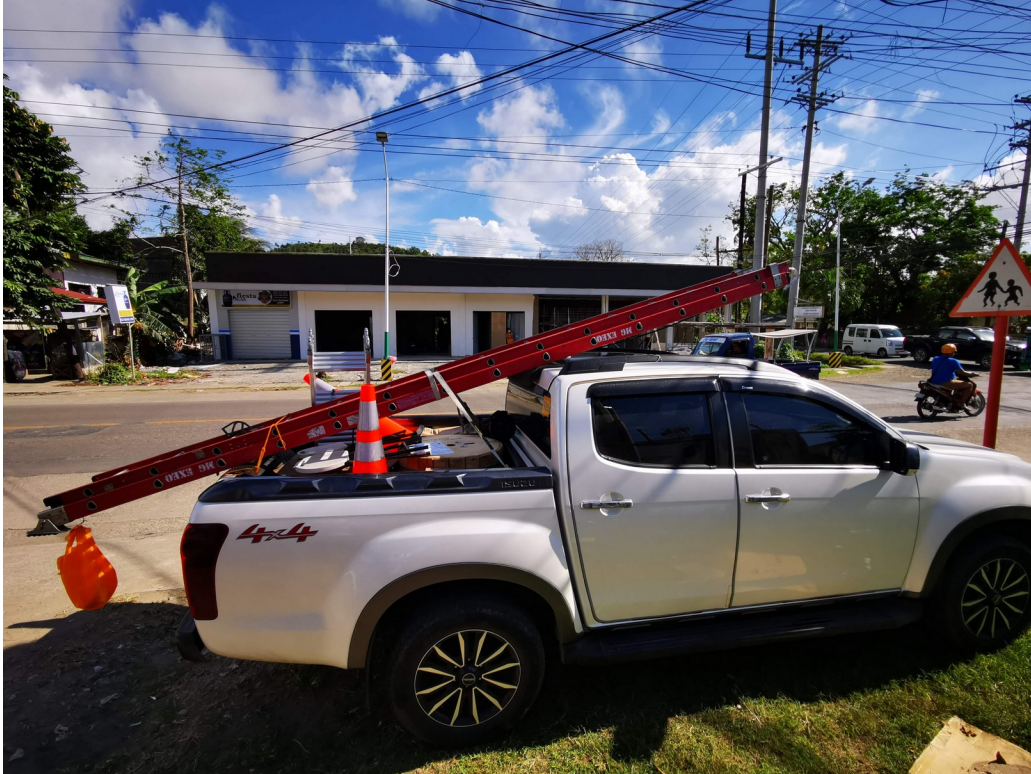
Figure 1. My service vehicle is packed with essential tools and equipment

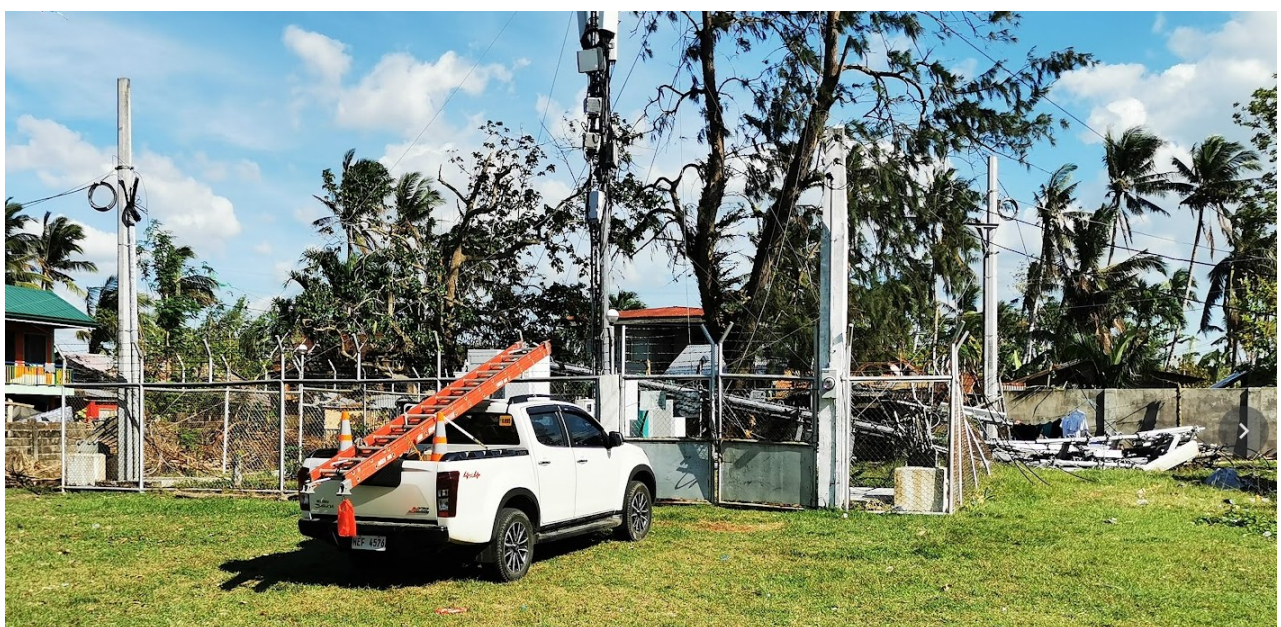
1. **Initial Assessment:** Upon arrival, I assessed the extent of the damage. Due to the aftermath of the typhoon, most areas were plagued with debris and fallen poles and lacked electric power. I prioritised areas with power to ensure immediate connectivity.
2. **Access Node Check:** Before starting the restoration, I ascertained the condition of the access nodes. Many of Globe's towers had toppled, making it crucial to check node serviceability. An example of a toppled tower located somewhere near Toledo City is shown in Figure 2 below.

Figure 2. A toppled tower located somewhere near Toledo City

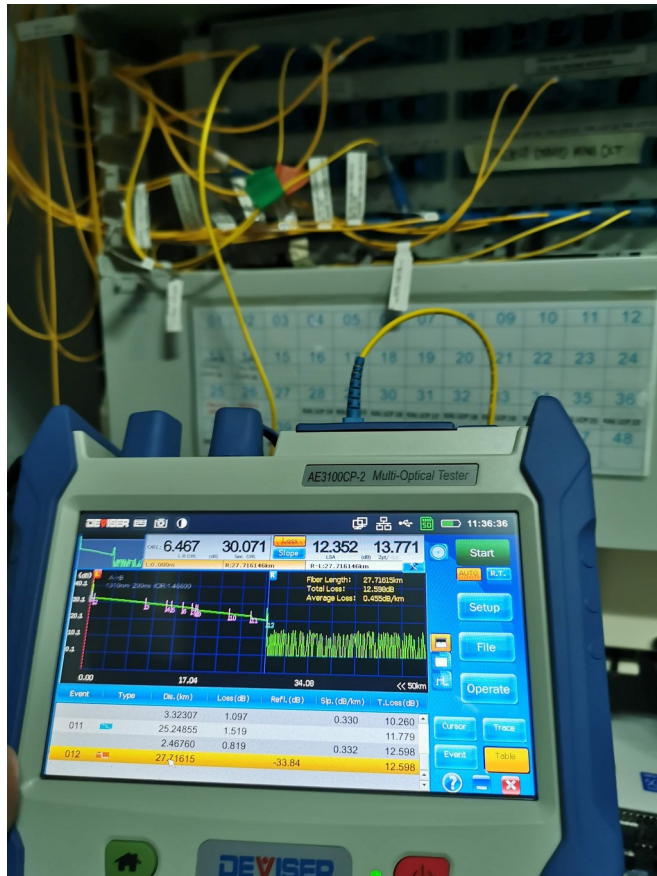
3. **Fault Detection:** Using the Optical Time Domain Reflectometers (OTDR), a sample of OTDR testing during Cebu restoration for one of the clients is shown in Figure 3 below. I precisely located faults in the fibre network, ensuring targeted and efficient repairs.

Figure 3. Testing of fibers using OTDR

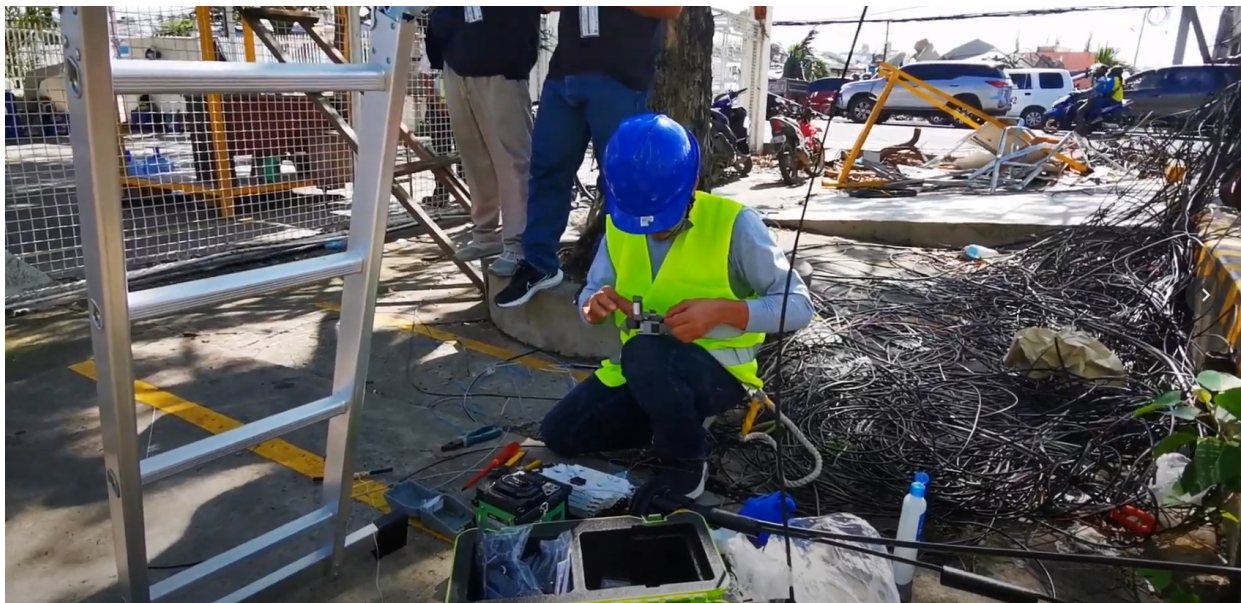
Figure 4. Preparation of fibre for splicing.

- I cleaned the fibre ends using alcohol and lint-free wipes.
- I stripped the outer jacket of the fibre cable to expose the inner cladding and core.
- My partner prepared the fibres by cleaving them, achieving a sharp and clean cut suitable for splicing, as depicted in Figure 4 below. Meanwhile, I set up the OTDR. In the background, you can see scattered debris and downed cables and wires.

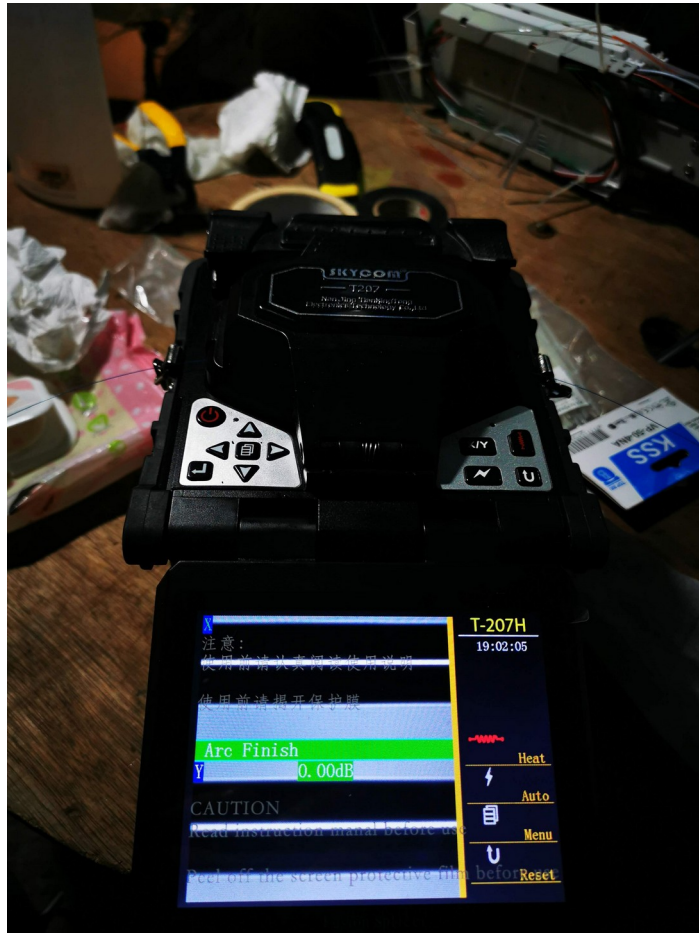
Figure 5. As seen on the OTDR display, I have just finished splicing the fibre.

- I joined the prepared fibre ends using the fusion splicer, melting their ends and fusing them together. I just completed the splicing of fibre as shown in the display of OTDR in Figure 5 below.

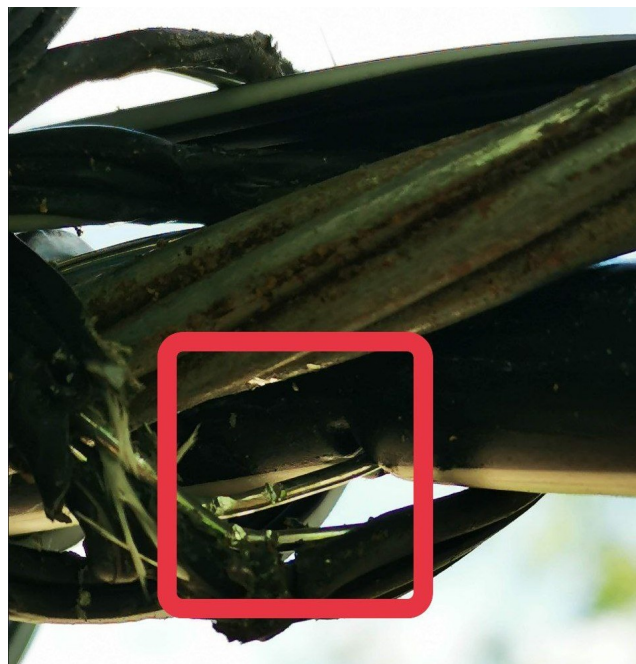
- I deployed a Power Meter and Light Source to test the quality of the splice.
- I used an OTDR to measure the splice loss and verify the quality of our work.
- Addressing a partial cut, as shown in Figure 6 below, presents the most significant challenge in fibre restoration. Unlike a complete severance, where the issue is evident, partial cuts may only damage some fibres within the cable, leaving others intact. This makes it difficult to pinpoint the exact location of the damage, requiring more in-depth analysis and precision during the repair process. Furthermore, these partial cuts can introduce significant signal loss or intermittent issues, which can be harder to diagnose compared to the total loss of signal in a full cut. Thus, both the detection and repair of partial cuts demand meticulous attention and expertise.

Figure 6. Fiber optic cable partial cut due to pinching of lashing wire

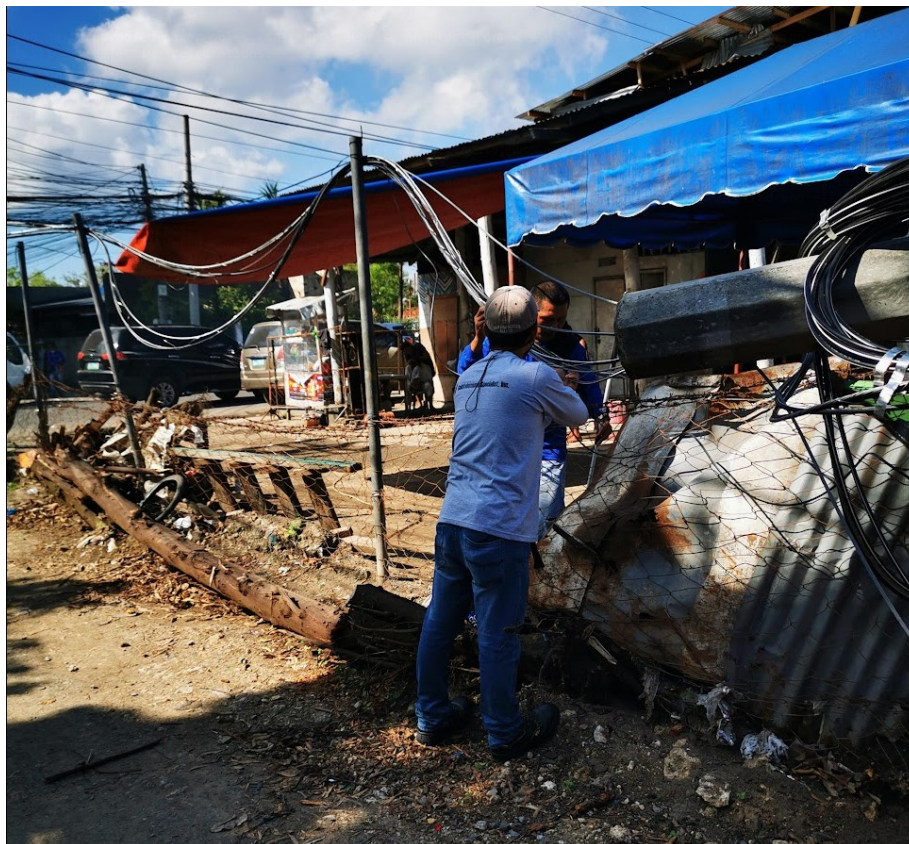
Figure 7. *Steel columns are temporarily used for fibre attachment*

- I secured the new fibre cables. Although many were affixed to existing infrastructure, we creatively anchored some to trees or steel columns as temporary solutions because of the typhoon's destruction, as illustrated in Figure 7 below with my partner and me.
